Dipl.-Ing. H.H. Neuburg

Avoidance of Macrofouling by Algae (*Cordylophora caspia*) in Cooling Water Systems by the Application of Automatic Backwash Filters

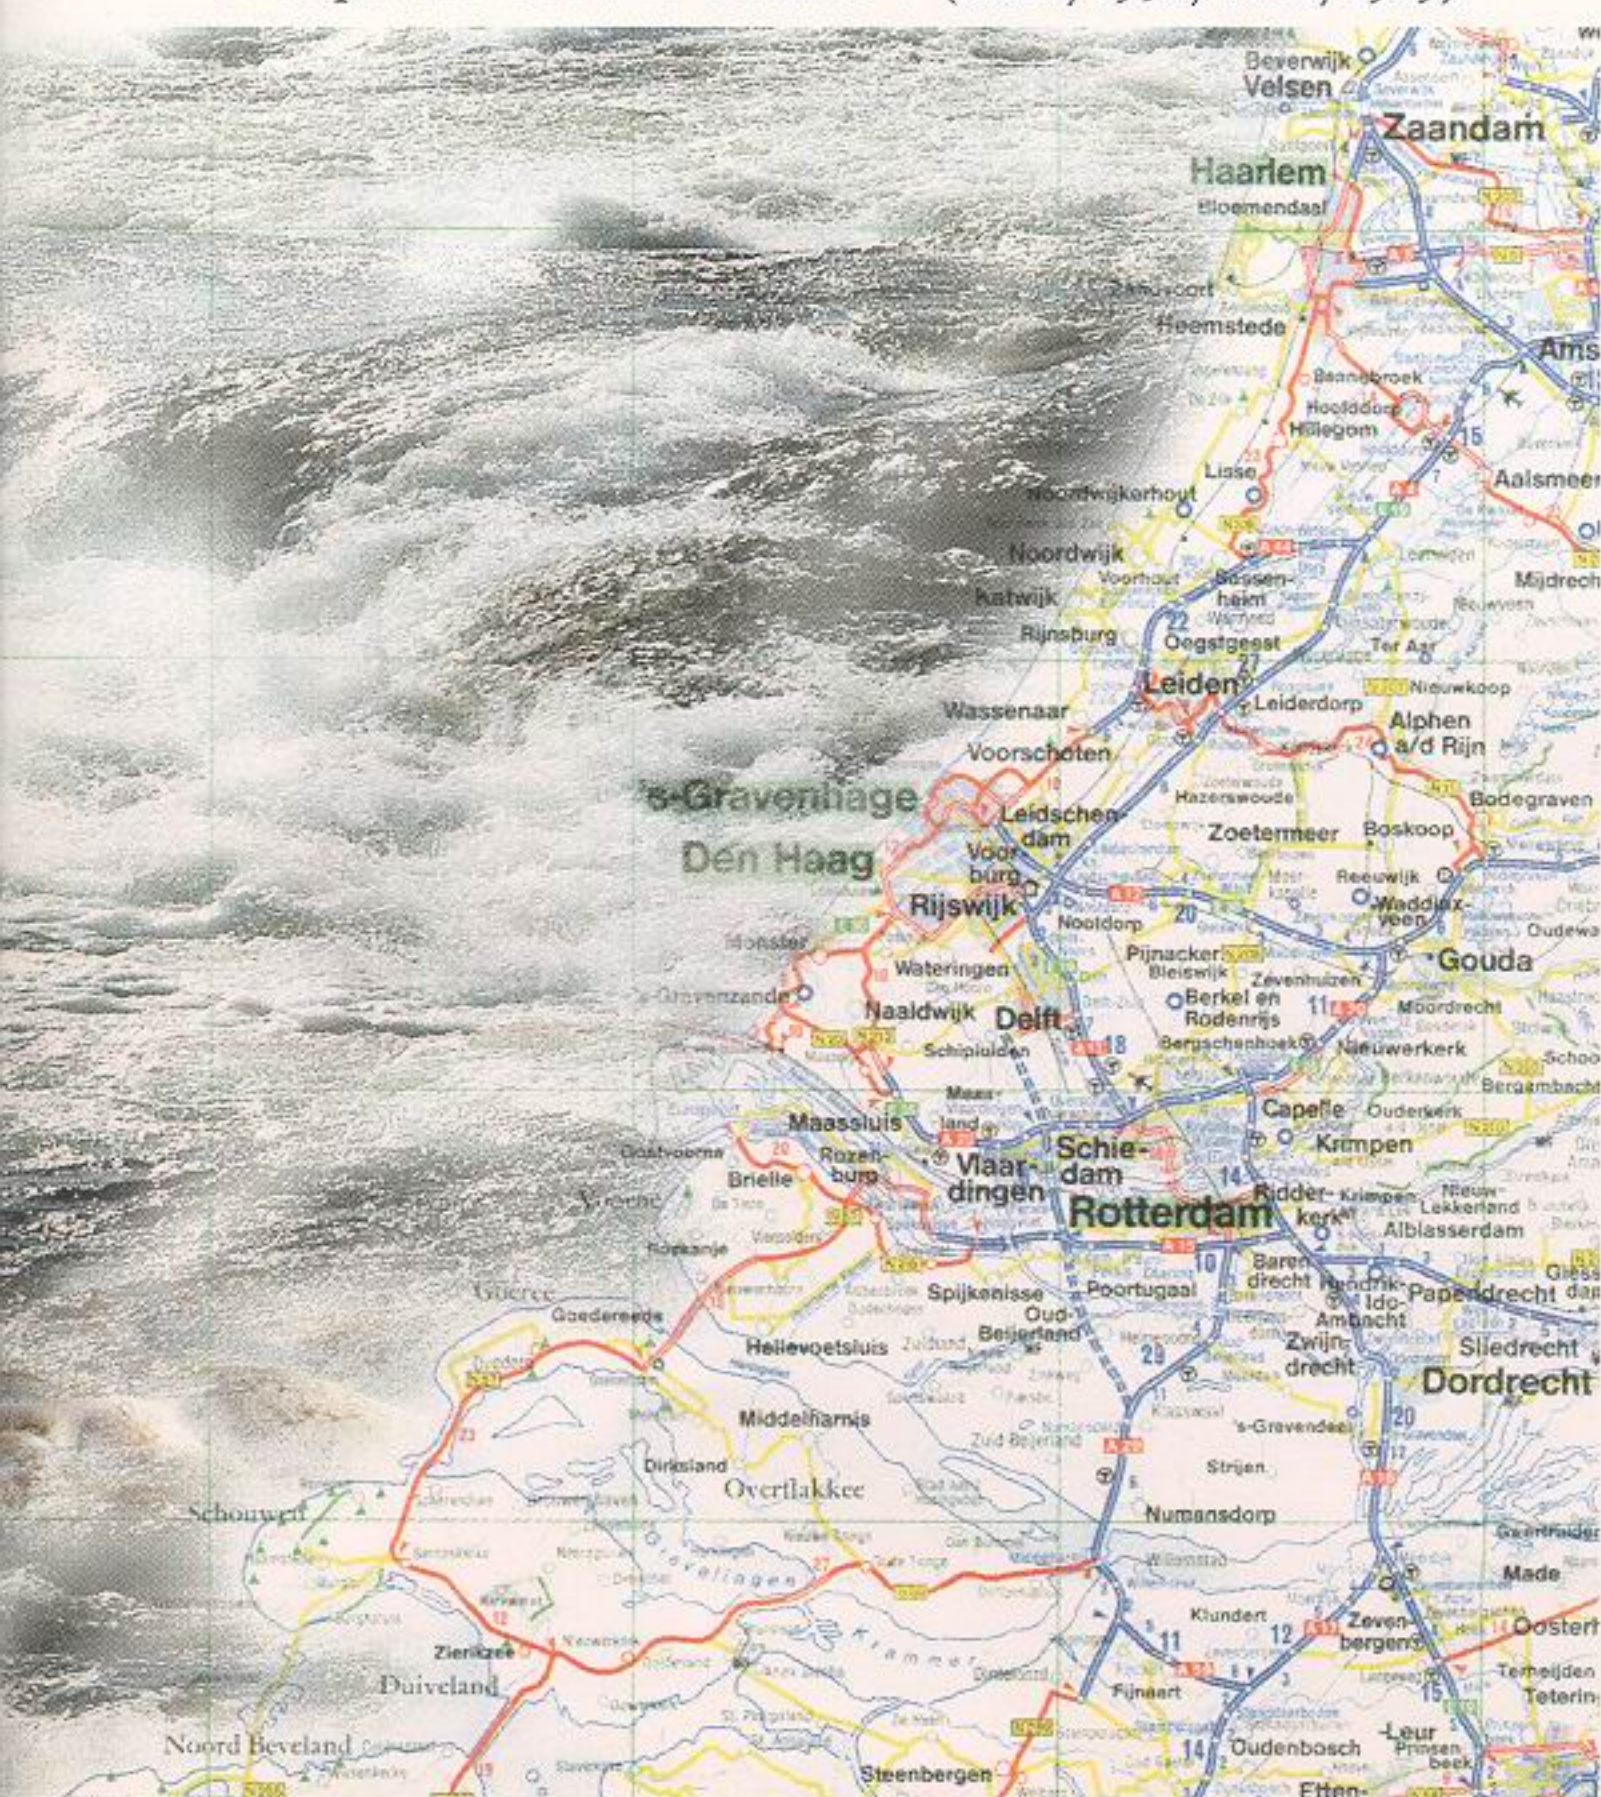
Distribution of *C. caspia* (colloquial: "Apehaar" = monkey's hair) in the Netherlands

The known settlements are marked on the map of the coastal region of the Netherlands (fig. 1). It concerns the Noordzeekanaal, the river Maas and the Westerschelde. From the power stations and chemical plants located there, vast experience is available which shall be explained by some examples.

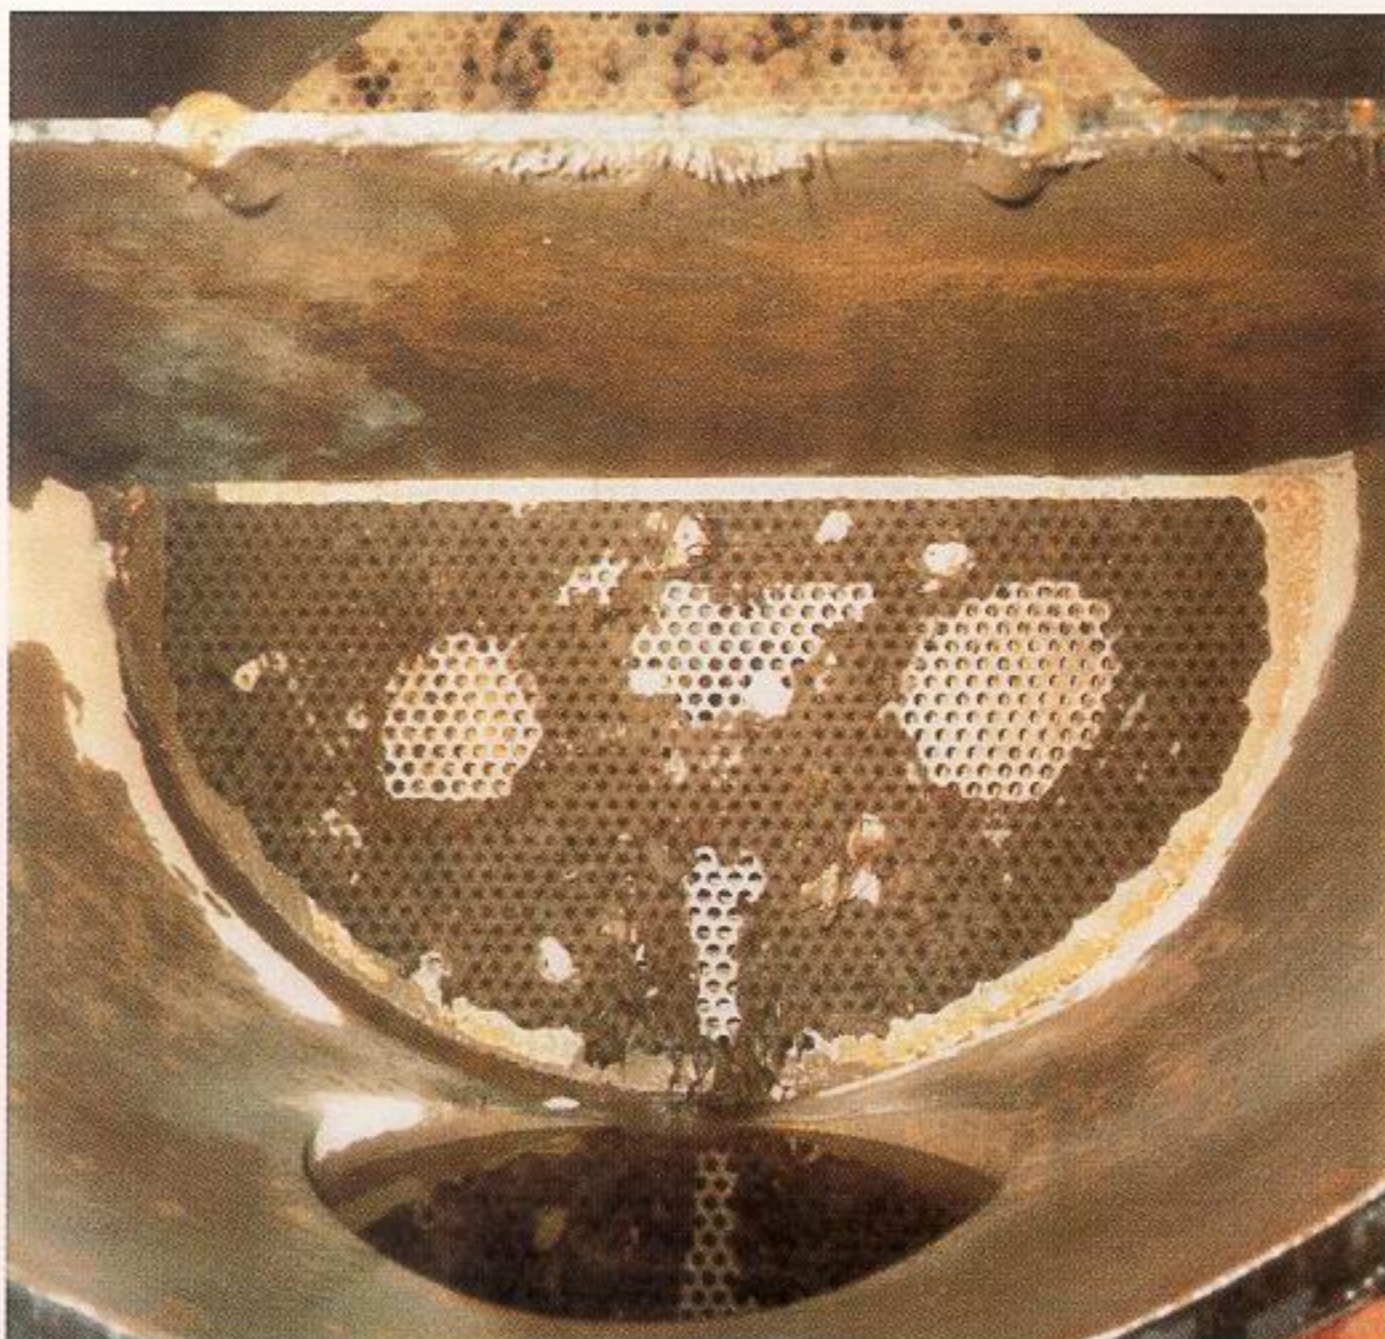
Rozenburg is situated approx. 10 km downstream of Pernis. Fig. 4 shows an open shell and tube heat exchanger whose tube plate is nearly completely matted by strongly adherent and dead *C. caspia*. In this case, manual cleaning is the only cleaning method which can be performed only with considerable efforts. On the extended plant site, a new desalination plant for brackish water shall be taken in operation which, with regard to filtration, will be confronted with the same problems. The fouling to be mastered consists of a mixture of *C. caspia*, mussel shells, sea-pocks, sand and fine dust, as shown on fig. 5 and 5a. Except for the fine dust that might be in a size of approx. 5 µm, we are faced with a difficult mixture of macro-fouling which may clog the spray jets and strongly impair plant operation.

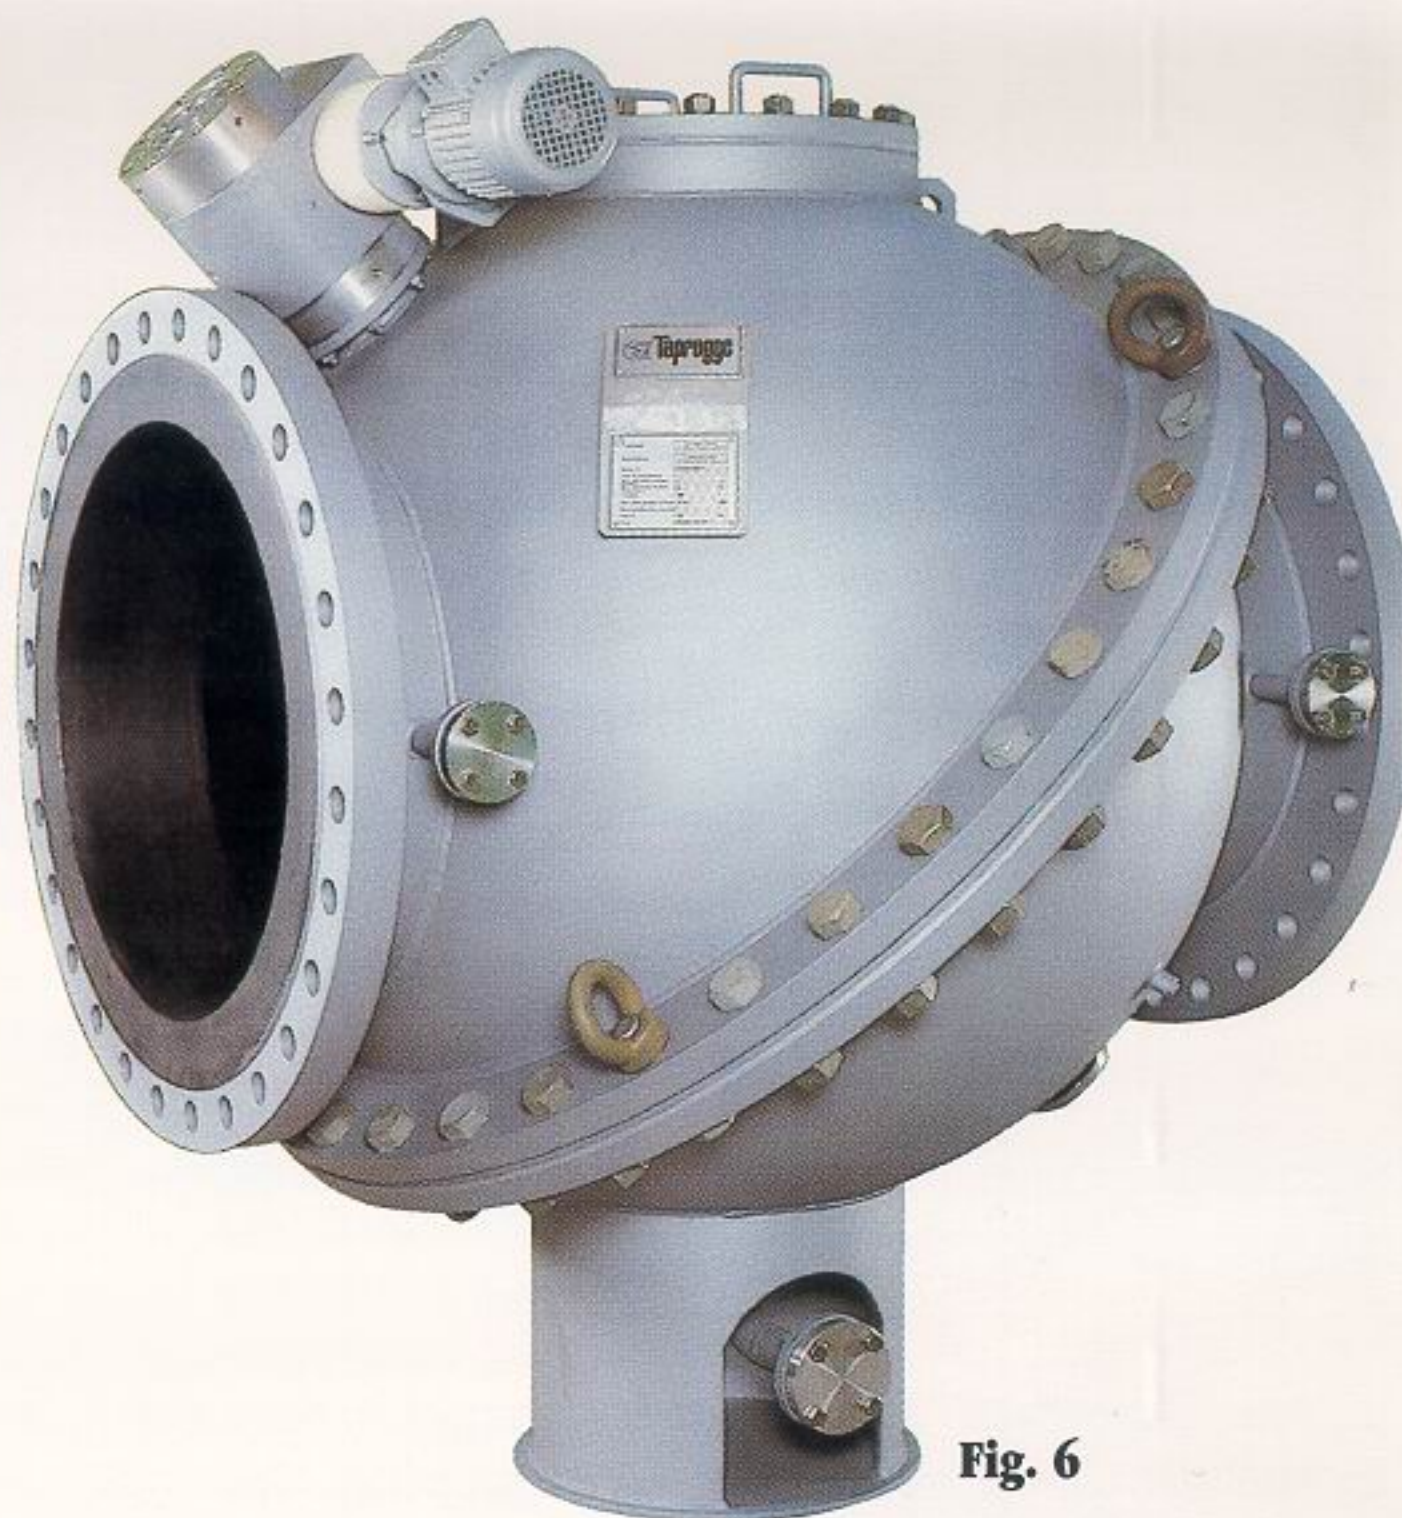
Fig. 6

The filter consists of a spherical housing which is divided in the middle and connected by mating flanges (fig. 6). Between these flanges, the filter section (item 2) is installed – a perforated steel sheet. Gaps between clean and inlet water side are avoided, so that debris particles have no chance to pass by the filter screen. The size of perforation depends on the type of debris. In special cases, such as with the filtration of "apehaar", its definition requires large-scale tests.

On the inlet water side of the filter section, a backwash rotor (item 3) is arranged. The rotor is guided by two bearings and driven by a gear motor (item 4). The inlet opening of the backwash rotor is designed as a suction channel

which partly covers the filter section. The channel inlet is provided with a flexible rubber sleeve and has a certain minimum distance to the filter section. A differential pressure measuring system (item 7) is connected to the nozzle DN 4.

The discharge valve (item 5) may not cause a contraction of the cross-section and is equipped with an actuator. The discharge pipe is connected with pipes of lower operational pressure, or is led directly to an open drain.

The special feature of the "Apehaar" Filter PR-BW 100-HP is a pressure-relieved chamber on the clean water side which travels with the backwash rotor with which it is connected.

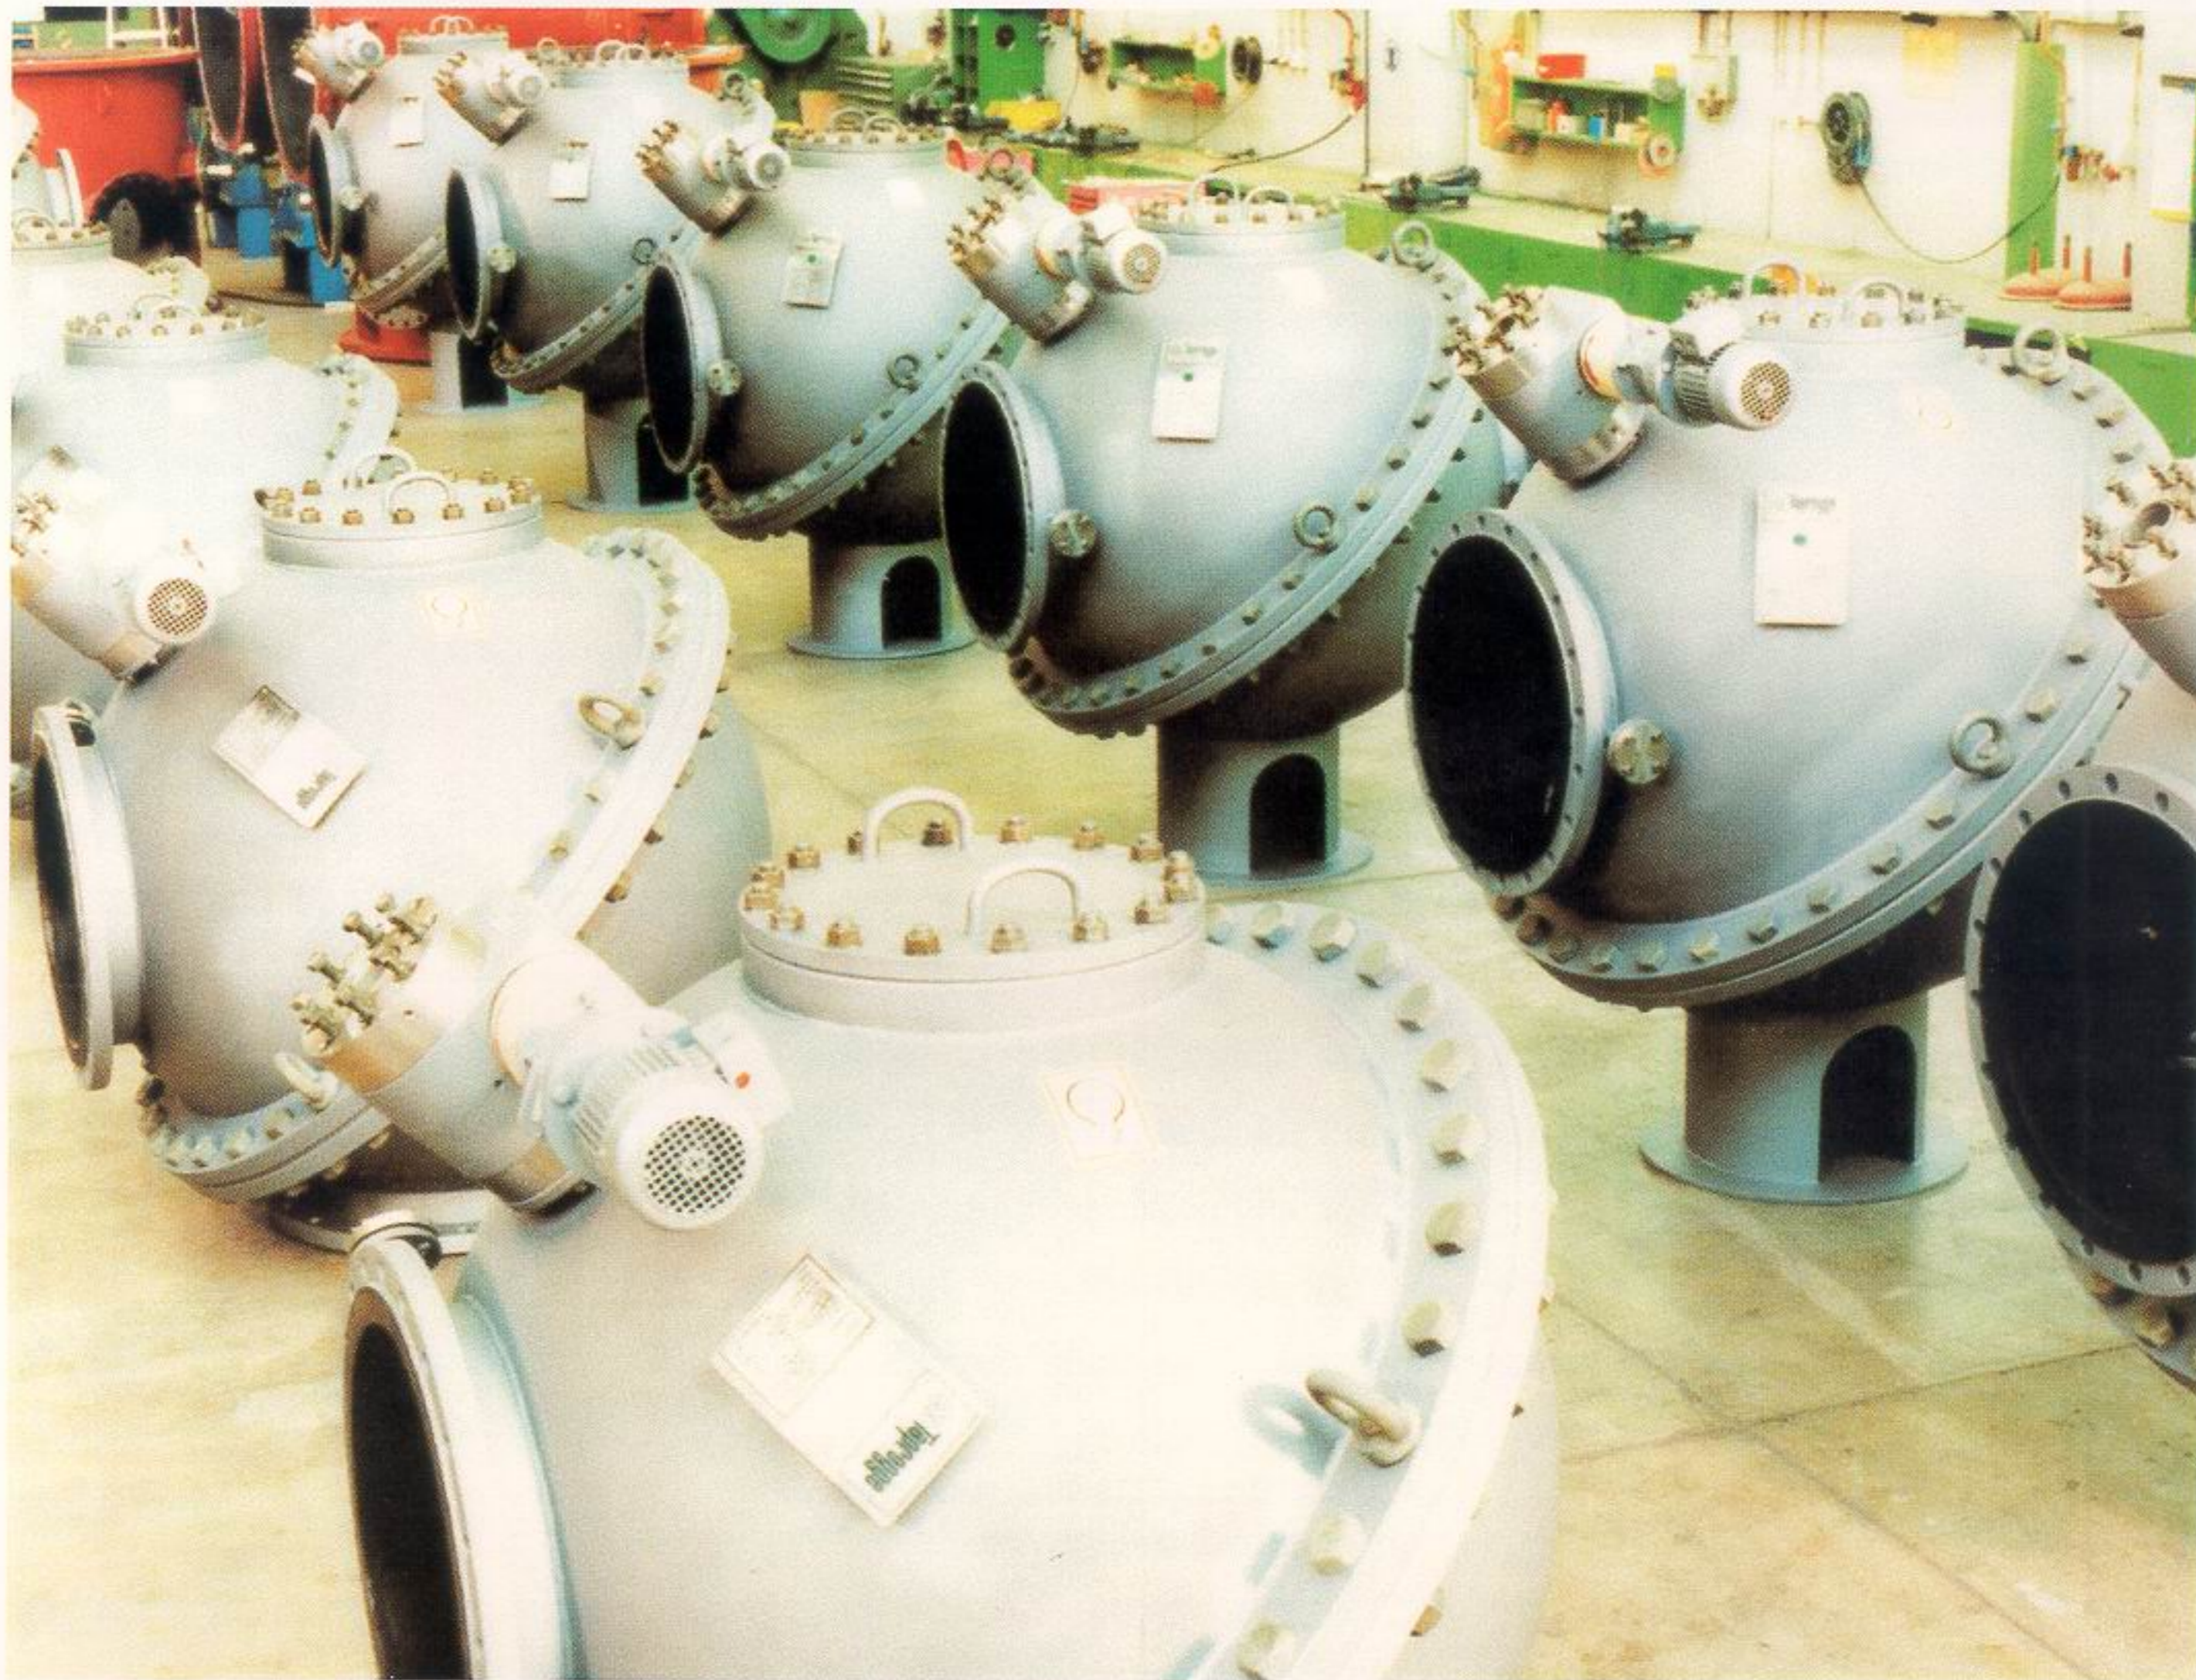
High-Performance Debris Filters PR-BW 100-HP in the Taprogge works

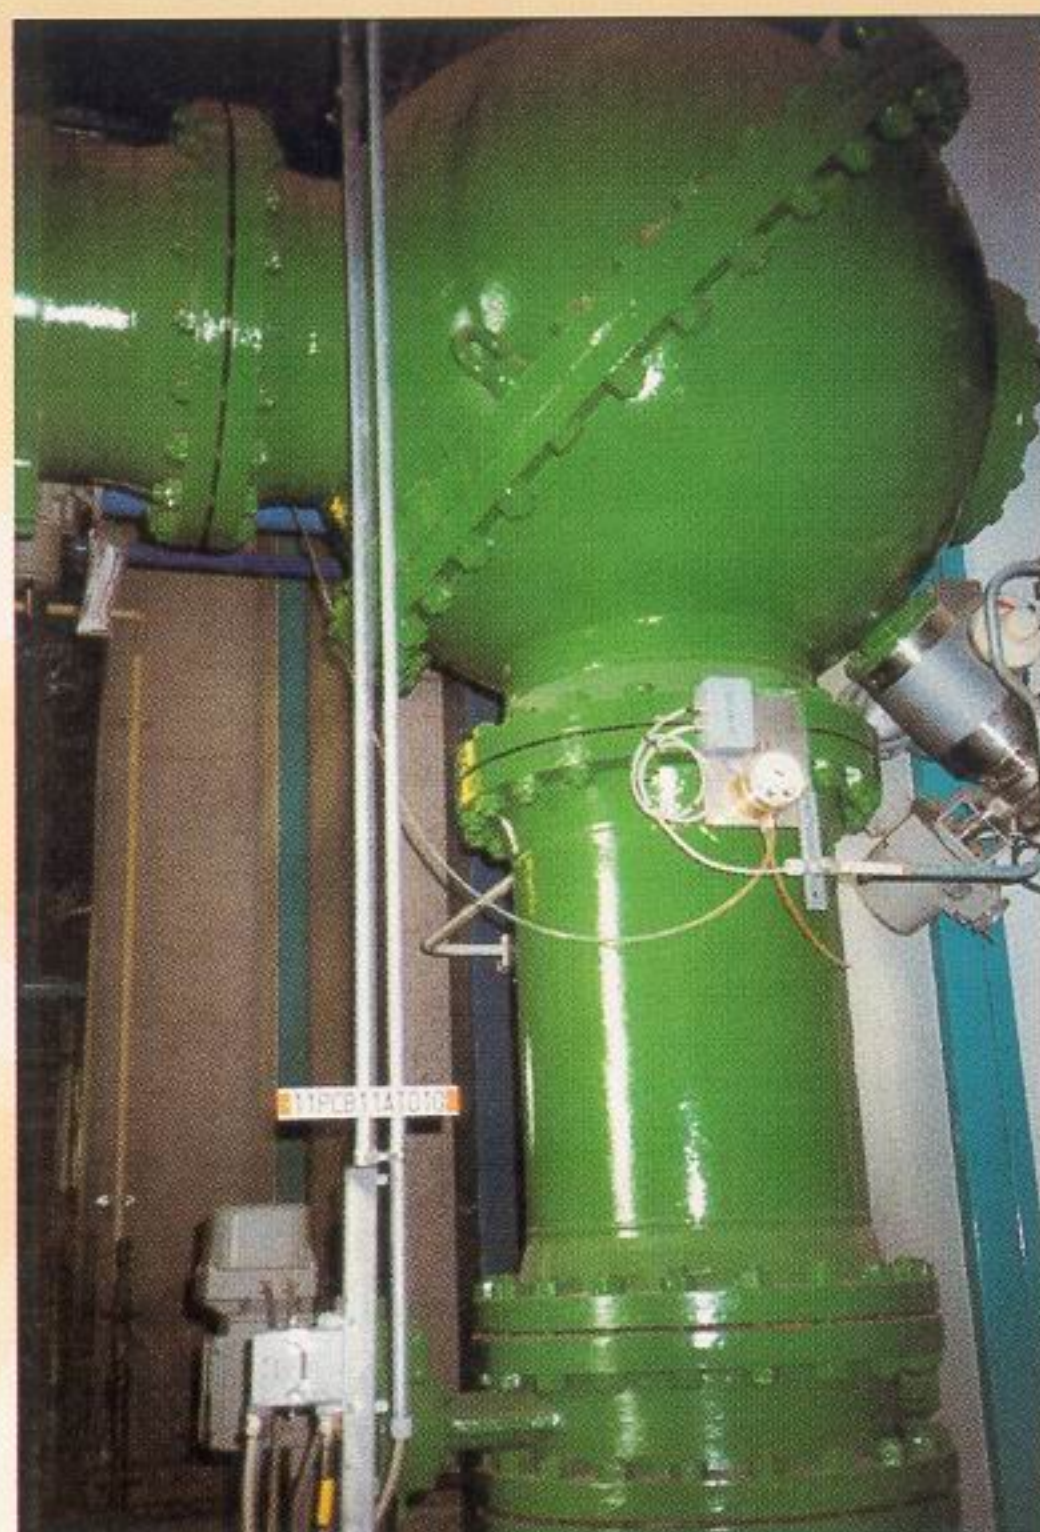
Fig. 9

The PR-BW 100-HP filter can be installed in any position, horizontally or vertically, and in any angle, either in a straight pipe or instead of a pipe bend (**fig. 9**).
