INTERNAL CONDENSER TUBE CORROSION ON CONDENSERS AND COOLERS IN POWER STATIONS

by P. H. Effertz, W. Fichte and P. Forchhammer

TAPROGGE Gesellschaft mbH

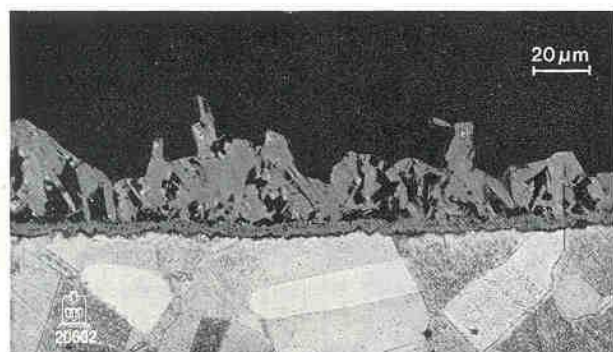
Figure 1. Double-lamellar covering layer $\text{Cu}_2\text{O}/\text{Cu}_2\text{O}-\text{CuO}$ on a heat exchanger tube of CuZn28Sn .

alloy and, secondly, a growing layer with varying conditions of thickness (9, 10). Mostly, the outer layer is formed of loosely linked single crystals only (Figs. 1 and 2).

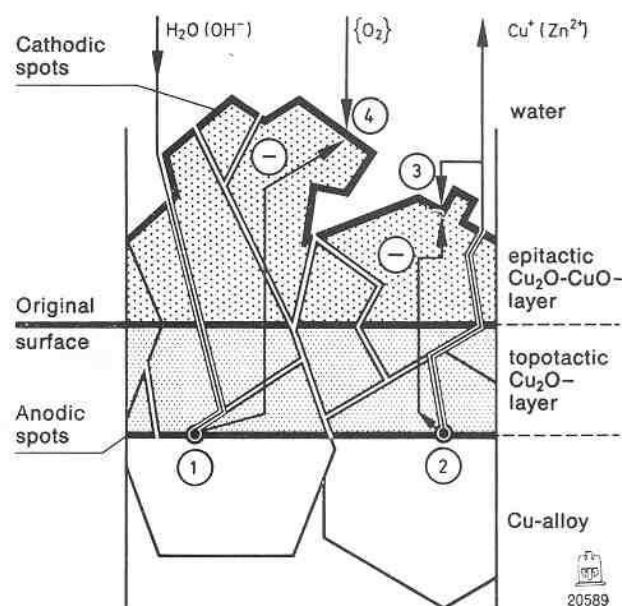
Figure 2. Formation of a Cu-alloy covering layer in water (schematic).

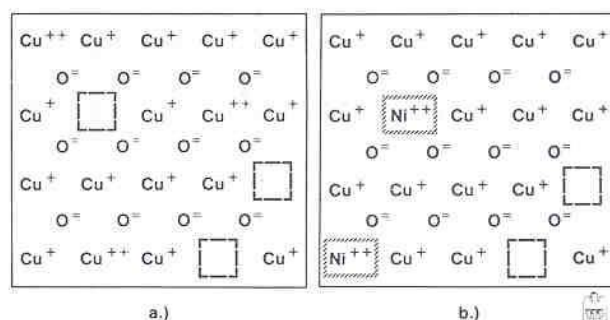
Figure 3. Schematic plan of the defective lattice
a) pure Cu_2O b) $\text{Cu}_2\text{O-NiO}$

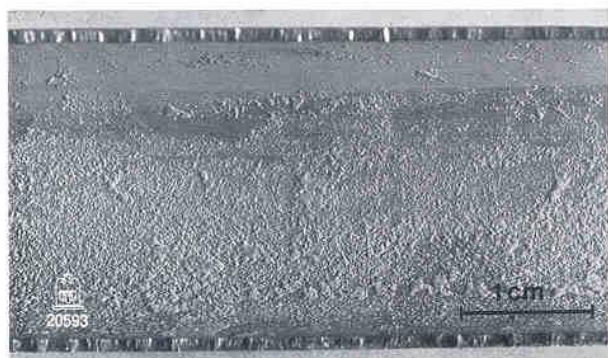
Figure 4. Pin-prick and broad-surface attack under a microporous protective layer of Cu_2O (pickled tube)

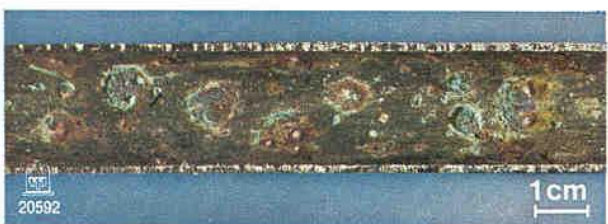
Figure 5. Abundant pitting in an auxiliary cooler tube (CuNi10Fe) at the end of the first few operating months.

operational down-times. Accordingly, new tubes often show numerous (Fig. 5) pin-prick corrosion areas during the initial operating phase, whereas only isolated cases of pitting are observed over longer operating periods (Fig. 6).

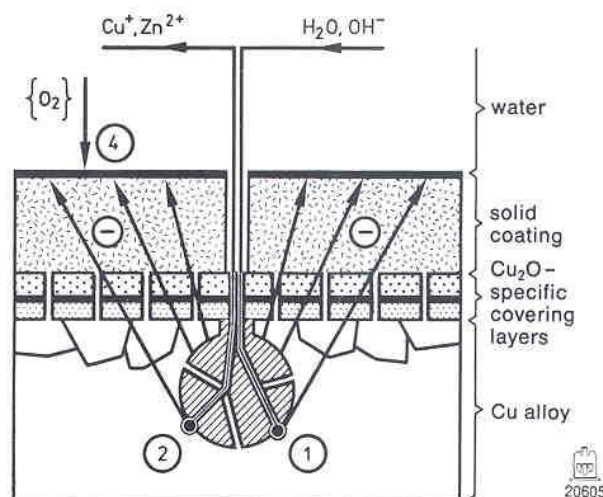
Figure 7. Formation of pitting under extraneous coatings (schematic).

Operationally occurring solids (for example: slime, calcite) can settle in layers on the tubes concurrently with the formation of microporous covering films. Such layers of more or less high conductivity act as expansive cathodic zones in which small uncovered surface can become anodic spots (Fig. 7). The covering largely inhibits the anodic reactions on the alloy surface by stopping-up the porous channels in the still thin Cu_2O -specific covering films. In contrast to this, the anodic reactions evolve at a greater rate underneath the small surface not covered with solid material because the entire cathodic current of the coating surface is available for the anodic dissolution current at that point (theorem of areas). Incipience of pitting at such points is the consequence.

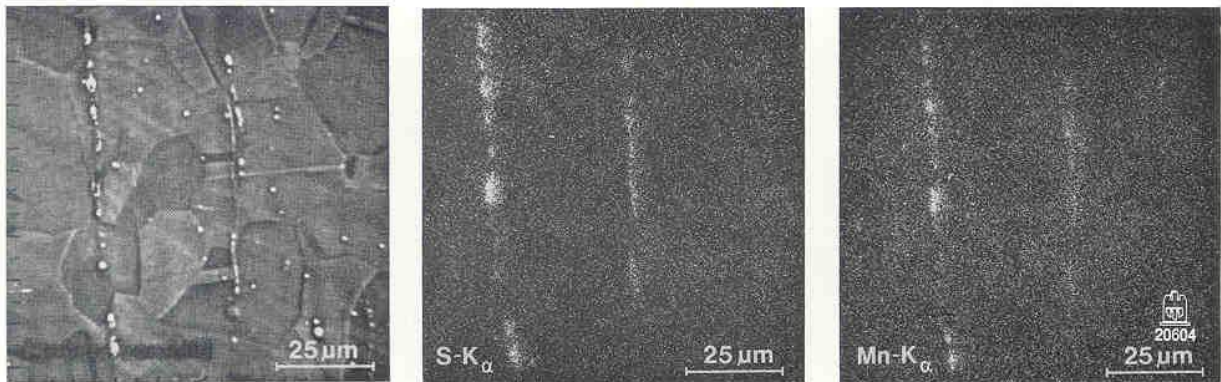
Figure 8. Manganese sulphide slags in CuNi30Fe.

Further spots for the tendency to form deep pitting holes during the initial operating period with new micropore-layered tubes are oxidic or sulphidic slag bands rising to the surface (Fig. 8) and cracked drawing lubricant residues. At the boundaries of the non-metallic inclusions resp. of the sintered carbon particles (Fig. 9), there appear, in the growing specific covering film, fissures which facilitate a mainly unhindered ingress of cooling water resp. the almost unhindered discharge of corrosion products. In conjunction with the relatively good electronic conductivity of the inclusion, an accelerated attack occurs at these boundaries. These spots largely determine therefore the location of the pitting.

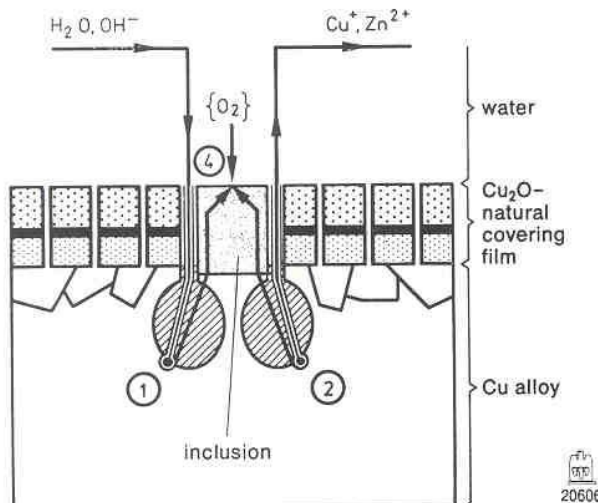
Figure 9. Formation of pitting at an inclusion (schematic).

The four starting-points of dangerous pitting shown in the sketches are characterized as small-surface anodic spots, surrounded by more or less covering-film-passive surfaces. At these points, there is an accelerated dissolution resp. oxidation of the alloy. The increased Cu concentrations lead via hydrolysis to acidification of the pitting electrolyte. This, in turn, causes a further acceleration of the active corrosion (2 a and 2 b). In contrast to Cu and Sn, the alloy elements Zn, Ni, Fe and Al are, according to the conditions prevailing, and with respect to pH value and potential, only existent in their ionic form and are therefore able to leave the pitting hole in the direction of the cathode (cooling water flow).

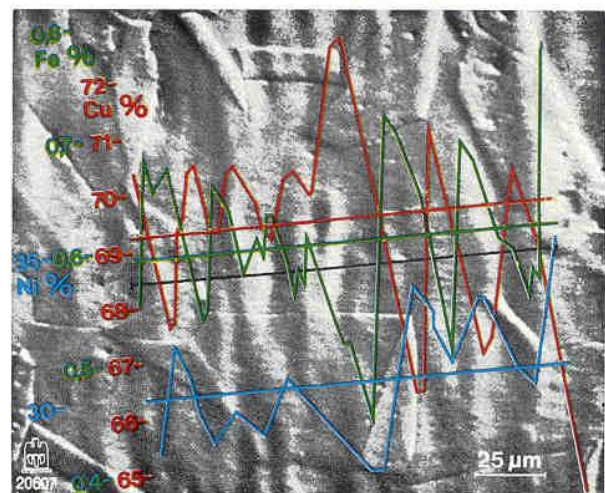
Figure 10. Concentration fluctuations in CuNi30Fe tubes resulting from block segregations.

Band structures in heat exchanger tubes resulting from ingot segregations are also said to be places conducive to pitting (Fig. 10).

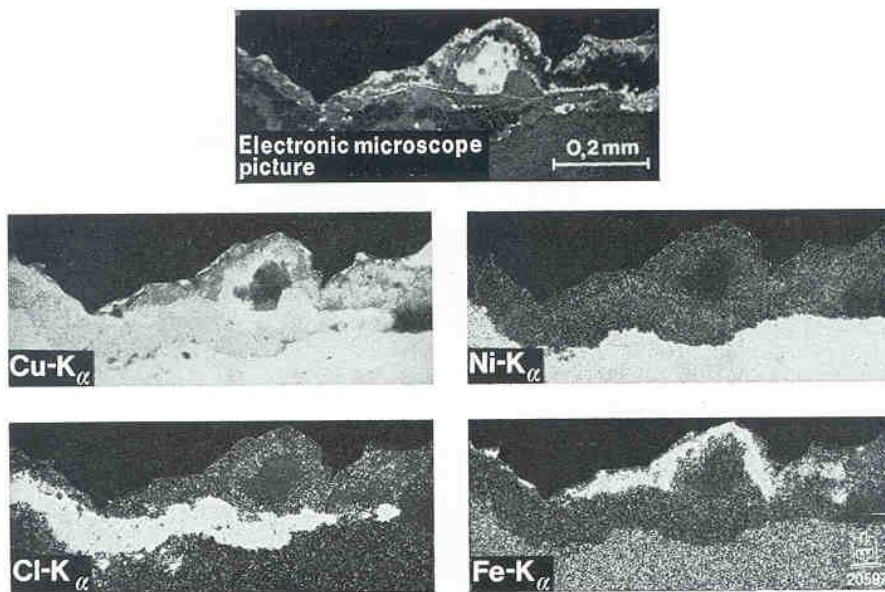
Figure 11. Distribution of elements in a pitting location (NiCu30Fe).

These conceptions are in keeping with electron diffraction analyses made at pitting locations in special brass CuNi and even in NiCu alloys (Fig. 11).

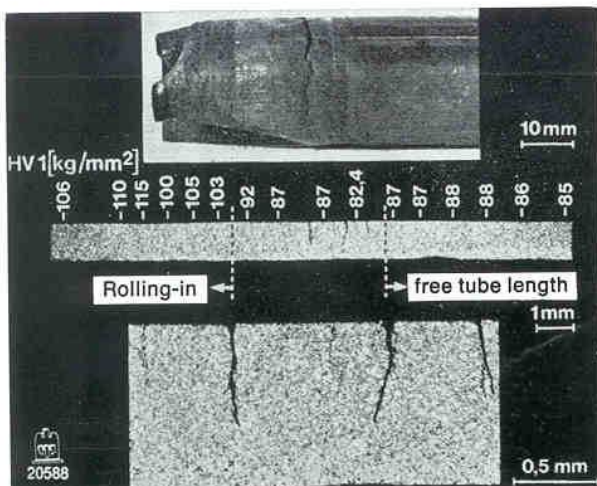
Figure 12. Stress corrosion cracking in the transition between the rolling-in zone and the free tube length.

explained in terms of the mechanism of stress corrosion cracking, beginning with pitting holes in the rolled-in tube zone. The formation of Cu_2O covering films outside and on the walls at the pitting points is always present in conjunction with dissolution in the pitting root. The lowest stress limit necessary for the formation of cracks is reached at the dislocation congestions in the pitting root subsequent to macrostructural slipping, because at that point there is a summation of strains due to operating pressure and to the natural stresses evoked by the rolling-in process.

For the most part, the transcrystalline transverse cracks in the transition zones remain approximately in the middle of the tube wall. One explanation for this is the entry into the seemingly neutral deformation fibre, at which the intrinsic strains transmute to compressive strains. We consider that only very few incipient cracks become through-cracks, thus causing leakage, the being that the additional tensile stresses leading to a complete break-through are missing.

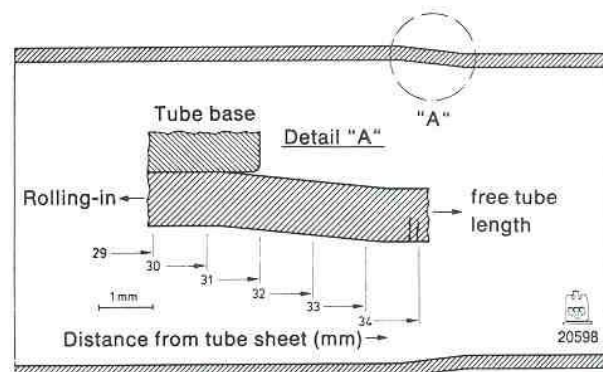
Figure 13. Beading transition (schematic).

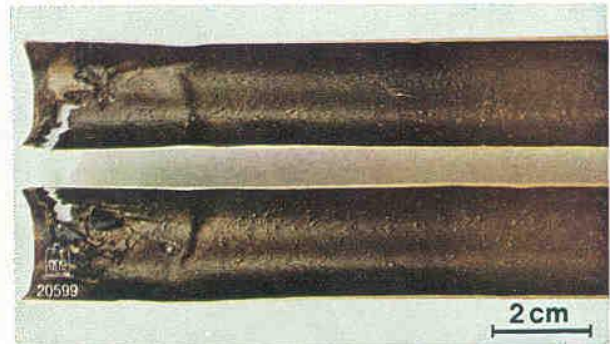
Figure 14. Erosion corrosion at the cooling water inlet end of a condenser tube (CuZn28Sn) caused by heavy intrusion of sand.

The cases of damage arising from erosion corrosion, as investigated by us, are confined to the inlet zones of the first and second water passes, to the small-surface erosive reductions in the free tube lengths, and to the effect of the flow on shallow pitting locations. Identical damage was observed on tubes with a deficient protective film, i.e. low resistance of the covering film to polarisation at estimated average flow rates around 2.0 m/sec. The causes recognized as being responsible for the erosion extending up to 10 cm in the tubes were the sporadic intrusion of sand (Fig. 14) resp. heavy incidence of air bubbles on account of the rise in the cooling water temperature in the summer months. Under such conditions, there is said to be a helical flow turbulence at the tube inlet.

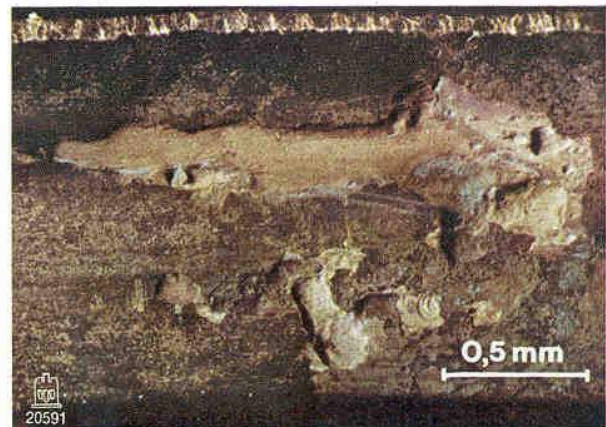
Figure 15. Erosive corrosion point in the free tube length (CuZn28Sn).

random along the free tube lengths. It can be assumed that solids have been temporarily held up at those points, thus interfering with the normal turbulence of the Reynolds type (Fig. 15).

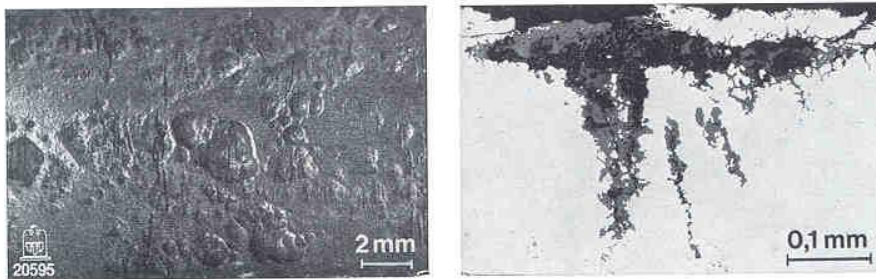
Figure 16. Low-cycle elongation fatigue cracks in an oil cooler tube (CuZn20Al) originating from corrosion pitting.

like fashion and become finer towards the ends of the cracks. They are very similar in form to stress corrosion cracks, so that a similar originating mechanism can be pre-supposed. Cracks of this kind are often observed in oil cooler pipes in the primary water circuit and develop mainly from pitting corrosion points (Fig. 16). It is evident that in such cases the alternating load appears in the form of temperature shocks after numerous operations of the coolers.

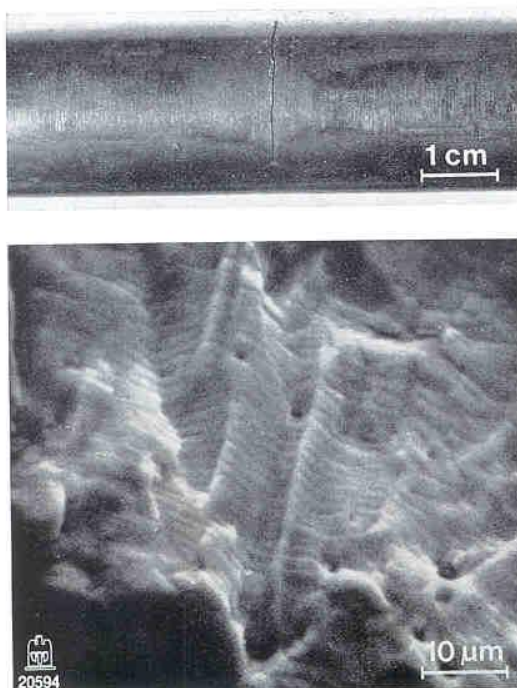
Figure 17. Fatigue corrosion crack in a tube (CuZn28Sn) from the steam admission zone between baffle plates.

Fatigue corrosion cracks which occur under high stress frequencies can also appear in tubes with a completely passive covering film. Often, only one crack running as a sharp incision into the material is observed (Fig. 17). At the breaking surface of such cracks, isolated interference bands can be recognised as a typical feature of alternating stress. Occasionally but rarely, damages resulting from such a cause can be seen on domes and tubes from steam admission zone where there is an intensive surge current resulting from bypass resp. over-production steam.

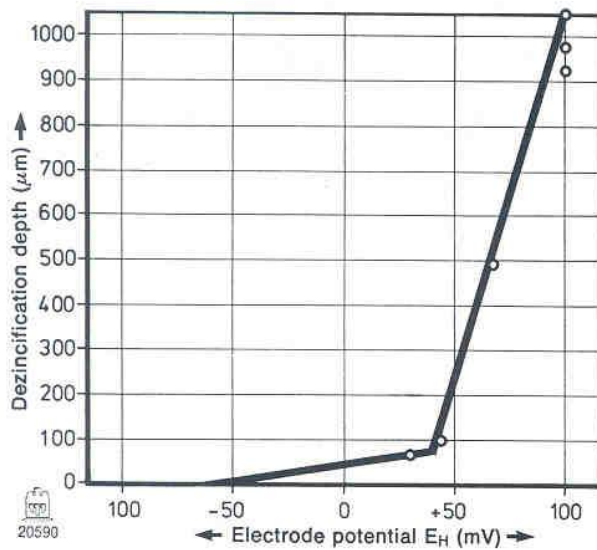
Figure 18. Dezincification depth of CuZn30 in a solution of CuCl_2 (5 g CuCl_2/l , 11 g HCl/ltr) after 48 hrs [29]

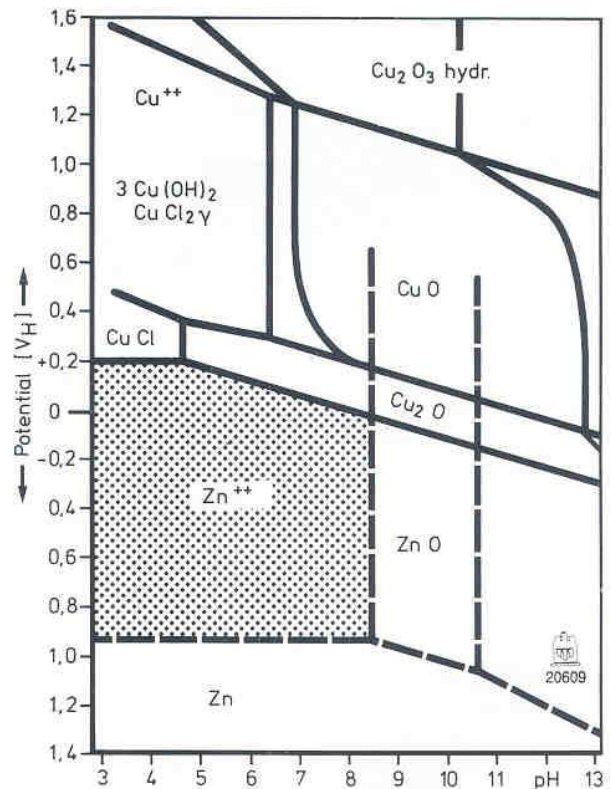
Figure 19. Simplified Cu-Cl- H_2O and Zn- H_2O chart (0.1 M Cl- and 10^{-6} M Cu and Zn ions).

superimposing over the theoretical potential-pH charts for the participating alloy elements Cu, Zn, Ni the experimentally derived potential-pH charts for the alloys under review (e.g. Cu-Zn, Cu-Ni) in chloride solutions [32]. In such observations, the variations of potential caused by alloy and solution activities, coupling processes and covering film formation are disregarded.

Exclusively selective dissolution of the more impure components Zn and Ni is possible with corrosion potentials lying above the dissolving potentials of Zn and Ni and below the precipitating potentials of Cu (Fig. 19). In the case of alpha brass, the range is from + 0.2 to - 0.94 V_H , whereby the values depend to a small degree on the ion concentrations in the solution (thermodynamically explicable dealloying range).

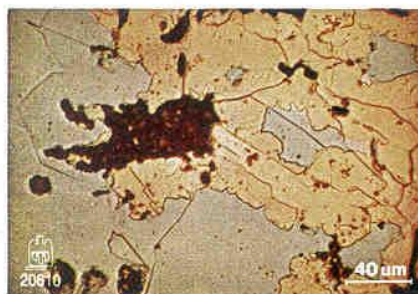
Figure 20a. Denickelisation of CuNi30Fe.

methods, that selective dissolution mechanisms were operating (Fig. 20 a and 20 b). In all cases, these processes occurred underneath porous covering films which had been formed in cooling water with a high chloride content.

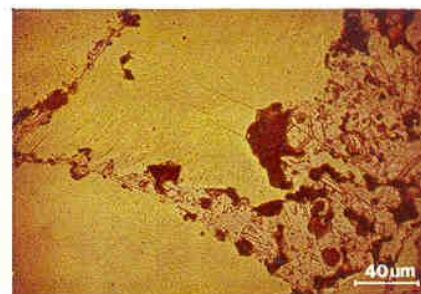
Figure 20b. Dezincification of CuZn28Sn.

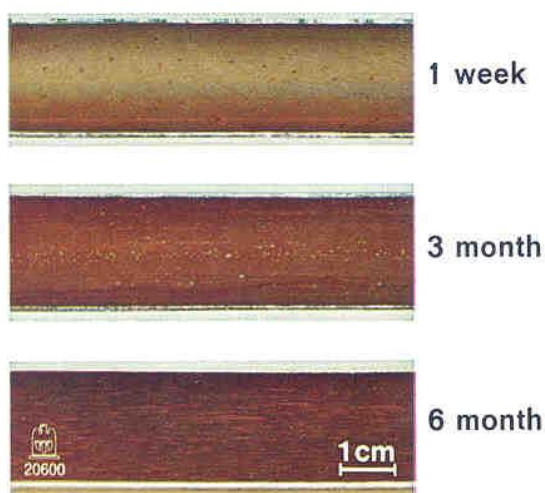
Figure 21. Change of colouring in condenser tubes (CuNi30Fe) through FeSO_4 injection.

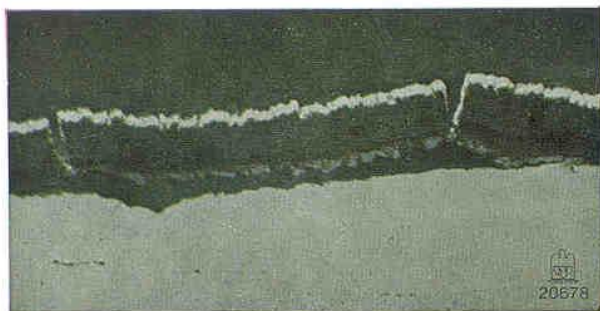
Figure 22. Hydrated FeO covering layer on a CuNi30Fe tube.

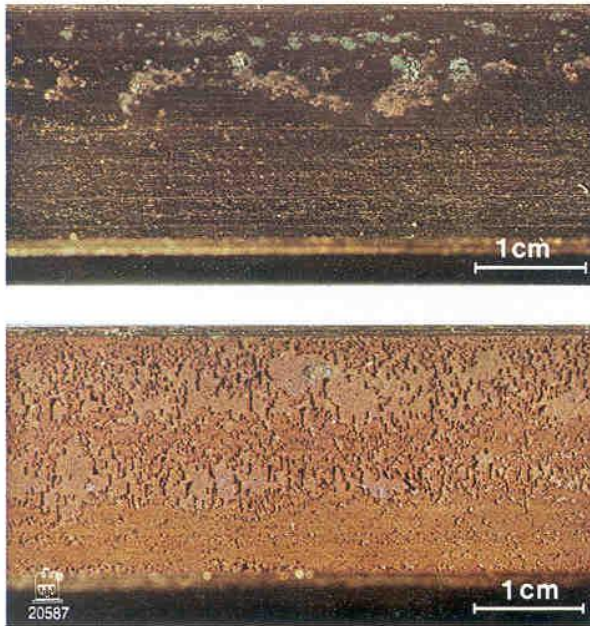
Figure 23. Condenser tubes before and after 1-year FeSO_4 injection.

tubes, but also to tubes already damaged by pitting corrosion and erosive corrosion (Fig. 23).

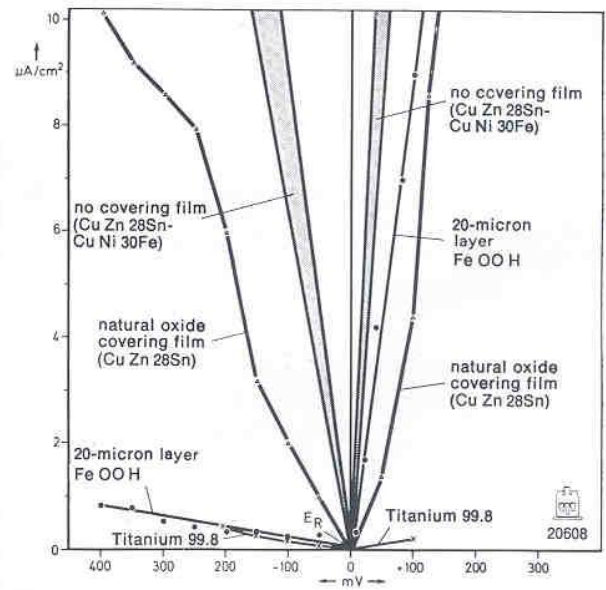
Figure 25. Potentiostatic polarisation graphs of industrial tubes in a 3% NaCl solution close to the no-load potential.

The objective appraisal of layer quality on copper alloys is important with respect to the general and selective behaviour of these materials under corrosion. The metallographical and visual methods of examination give only rough indications as to their properties and behaviour. On the other hand, an electro-chemical method enables the electronic and ionic resistance resp. the penetration polarisation of the anodic and cathodic reactions to be determined. In test sample tubes filled with a 3.4% NaCl solution, cathodic and anodic polarisation graphs are plotted up to a maximum current density of 10 microamps/

cm² (Fig. 25). The risings of the cathodic curves are directly proportional to the electronic resistance, whilst the risings of the anodic curves correspond with the ionic resistance.

Particularly striking is the high value of the electronic surface resistance in the external iron oxide layers (e.g. 580 mΩ/cm²) as against pickled tubes (8 mΩ/cm²) and defective natural films (11 to 15 mΩ/cm²). The influence of the external oxide layers on the ionic resistance is less pronounced. On the other hand, the natural oxide films seem to be of importance.

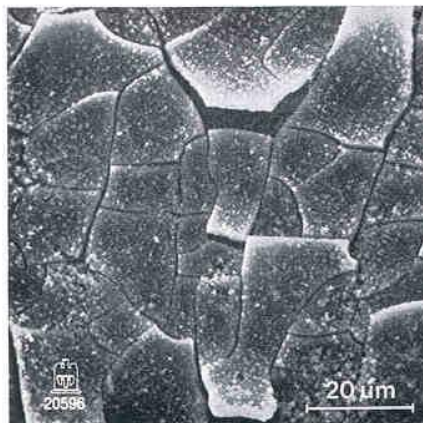
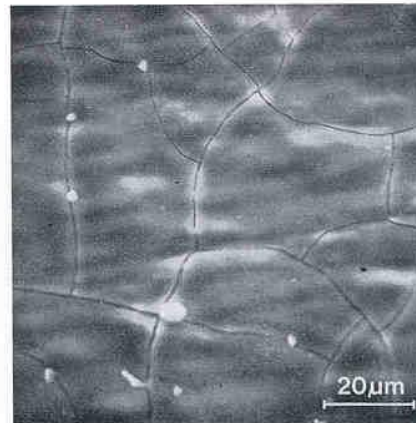
Figure 24. Oxide layers on condenser tubes injected with FeSO_4 , split and chipped on drying.
